## CHLORINE RESISTANCE TESTING OF PLASTIC PIPING MATERIALS

*P. Vibien, J. Couch and K. Oliphant, Jana Laboratories Inc., Aurora, ON  
W. Zhou, B. Zhang and A. Chudnovsky, University of Illinois at Chicago, Chicago, IL,  
USA, 60607*

### Abstract

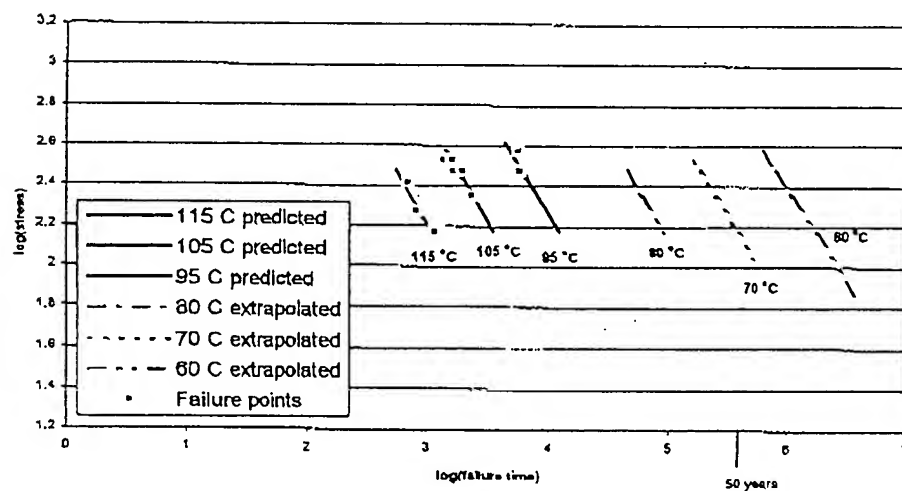
Figure 5: Failure Times for a PEX Pipe Material Exposed to Chlorinated Potable Water.

Figure 5 shows a plot of the experimental failure points and the predicted failure times from the Rate Process Model. From the data it is seen that the Rate Process Model provides a good fit to the experimental data. The  $R^2$  for the regression was 0.98. Also shown in Figure 5 are the extrapolated test lifetimes at lower temperatures.

For domestic plumbing applications the commonly accepted most aggressive end use conditions are 80 psi internal pressure and 60 °C (140 °F) temperature. In actual application both pressure and temperature, or the combination thereof, would be expected to be below these values. Moreover, most domestic plumbing systems do not experience continuous hot water conditions. These conditions would appear, therefore, to be relatively conservative. The extrapolated test lifetime for the PEX material tested based on these conditions is 93 years with a 95% lower confidence limit of 52 years. This estimate is based on testing at aggressive water quality conditions as well as extrapolation to aggressive end use conditions. Even though the presence of the chlorine in the potable water reduces the anticipated performance lifetime of the PEX pipe material tested, the material still appears to have very good chlorine resistance.
